Manhole Inspection Summary

Manhole # S01I2009MH

Insp Date: **8/7/06 9:53 AM**

Location Address: **Elray Dr**

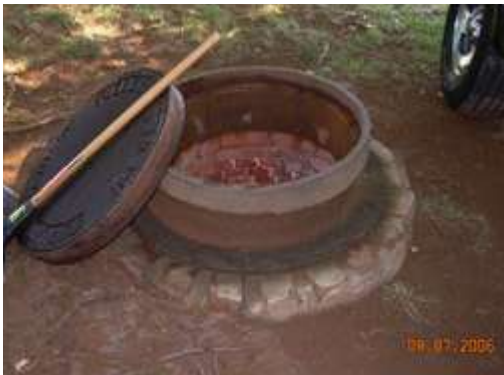
frame & cover - 1 foot above grade

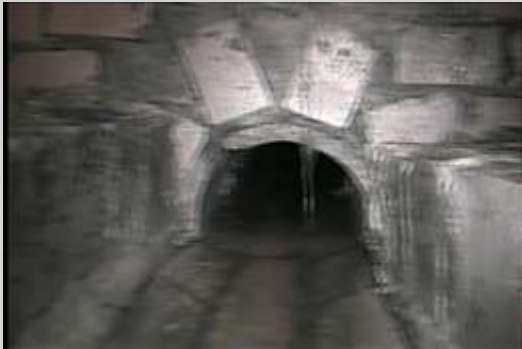
8 in. Circular Gravity Sewer Pipe Out @ 12 O'Clock

Pipe Material: **Clay** ☐ Pipe Lined

Invert Depth: **6.18** (ft.) Flow Characteristics: **Slow**

Infiltration: **None** Pipe Seal Cond: **Sound**

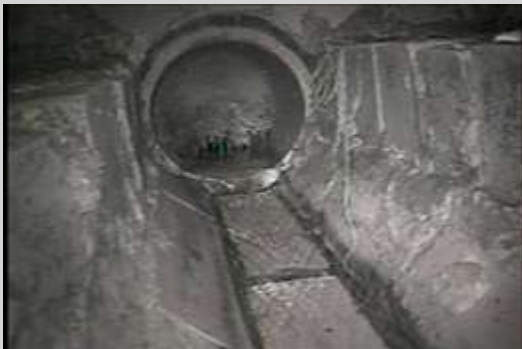
8 in. Circular Gravity Sewer Pipe In @ 3 O'Clock

Pipe Material: **Clay** ☐ Pipe Lined

Invert Depth: **5.76** (ft.) Flow Characteristics: **Slow**

Infiltration: **None** Pipe Seal Cond: **Roots**
